## **Final Report for PLP 25-0838: Survey of the Fox River at Oshkosh**

Brendon Baillod, Principal Investigator, WUAA

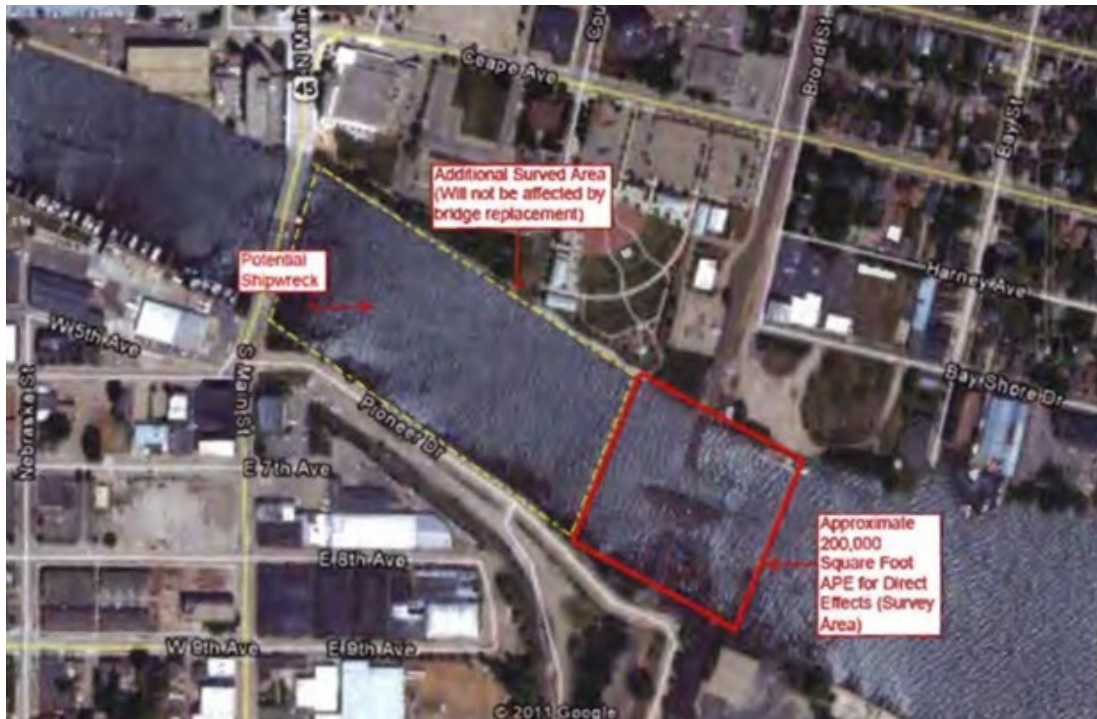
We were able to re-acquire the large target imaged by Jerry Guyer in 2017, just SE of the Hwy 45 Bridge. We collected multiple high-resolution images of this object, which is shown in figures 3 and 4 from Jerry Guyer's 2017 sidescan. This object sits on the edge of a channel in the river bed and is roughly square at 51 ft. long and 45 ft. wide. See Figs. 5, 6 and 7. We imaged this object in several passes and different resolutions and collected a great deal of morphological data for it. Tracks for two of the most revealing images are shown below.

Figure 3. The object labeled “Potential Shipwreck” was relocated and the same position shown here.

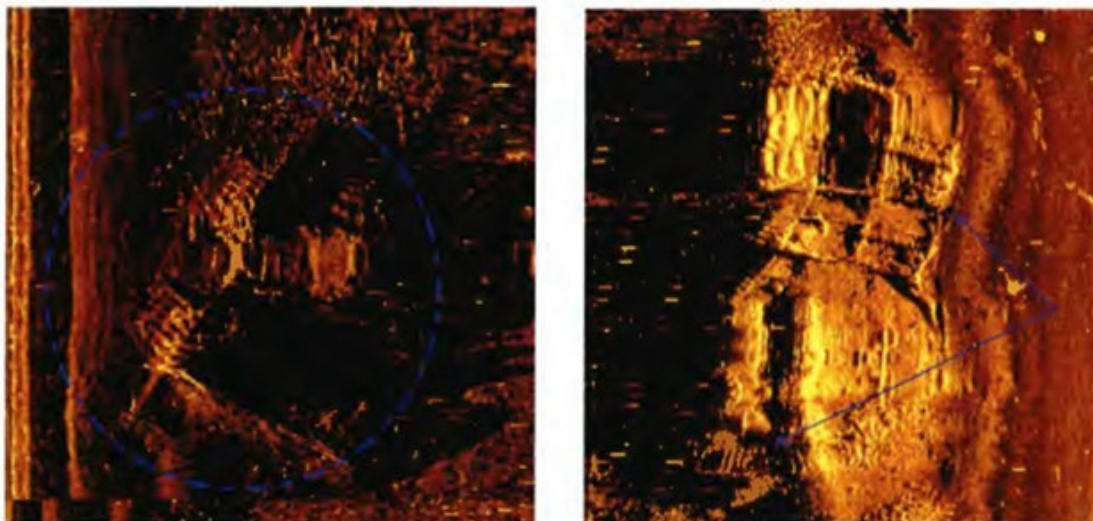
Figure 4. The object had approximately the same appearance

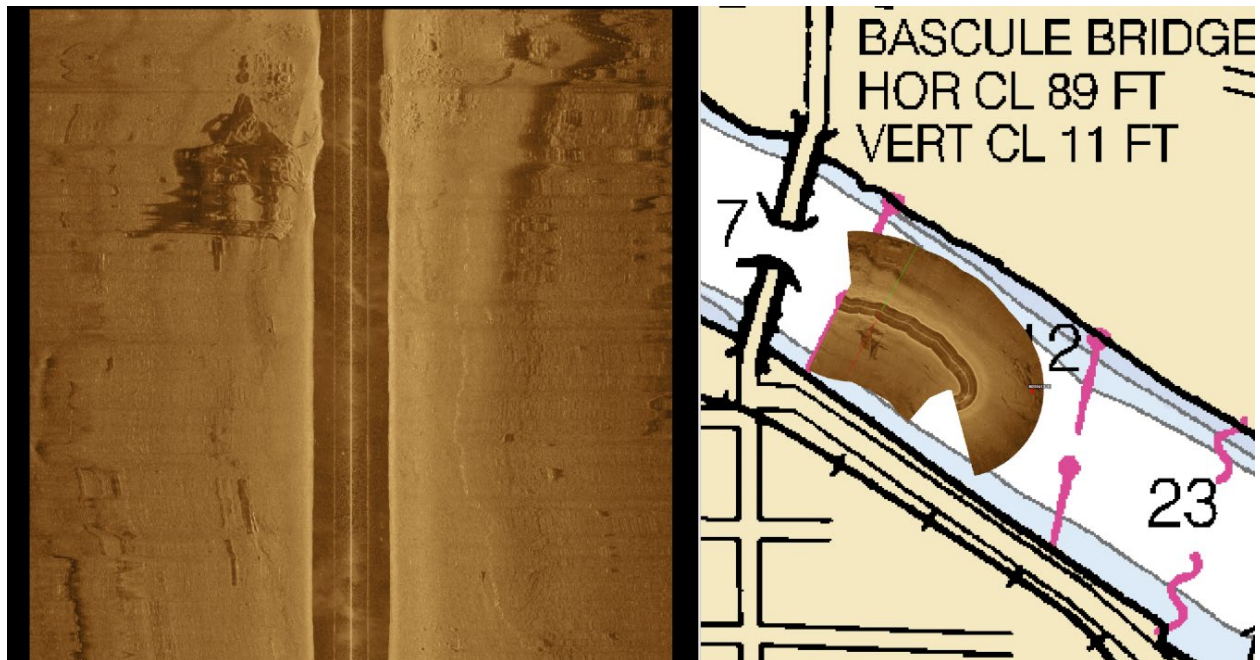
The object has features that rise nearly 9 ft. into the water column. This object is difficult to assess due to its differing appearance when imaged from different angles. It seem that it could be a section of an older bridge structure. However, there is also a possibility that this

could be the bow section of the early paddle steamer *Menasha* (see <https://www.wisconsinshipwrecks.org/Vessel/Details/431>). Her forward half was reportedly scuttled in the immediate area of this target.

Figure 5. Sonar image with mosaic

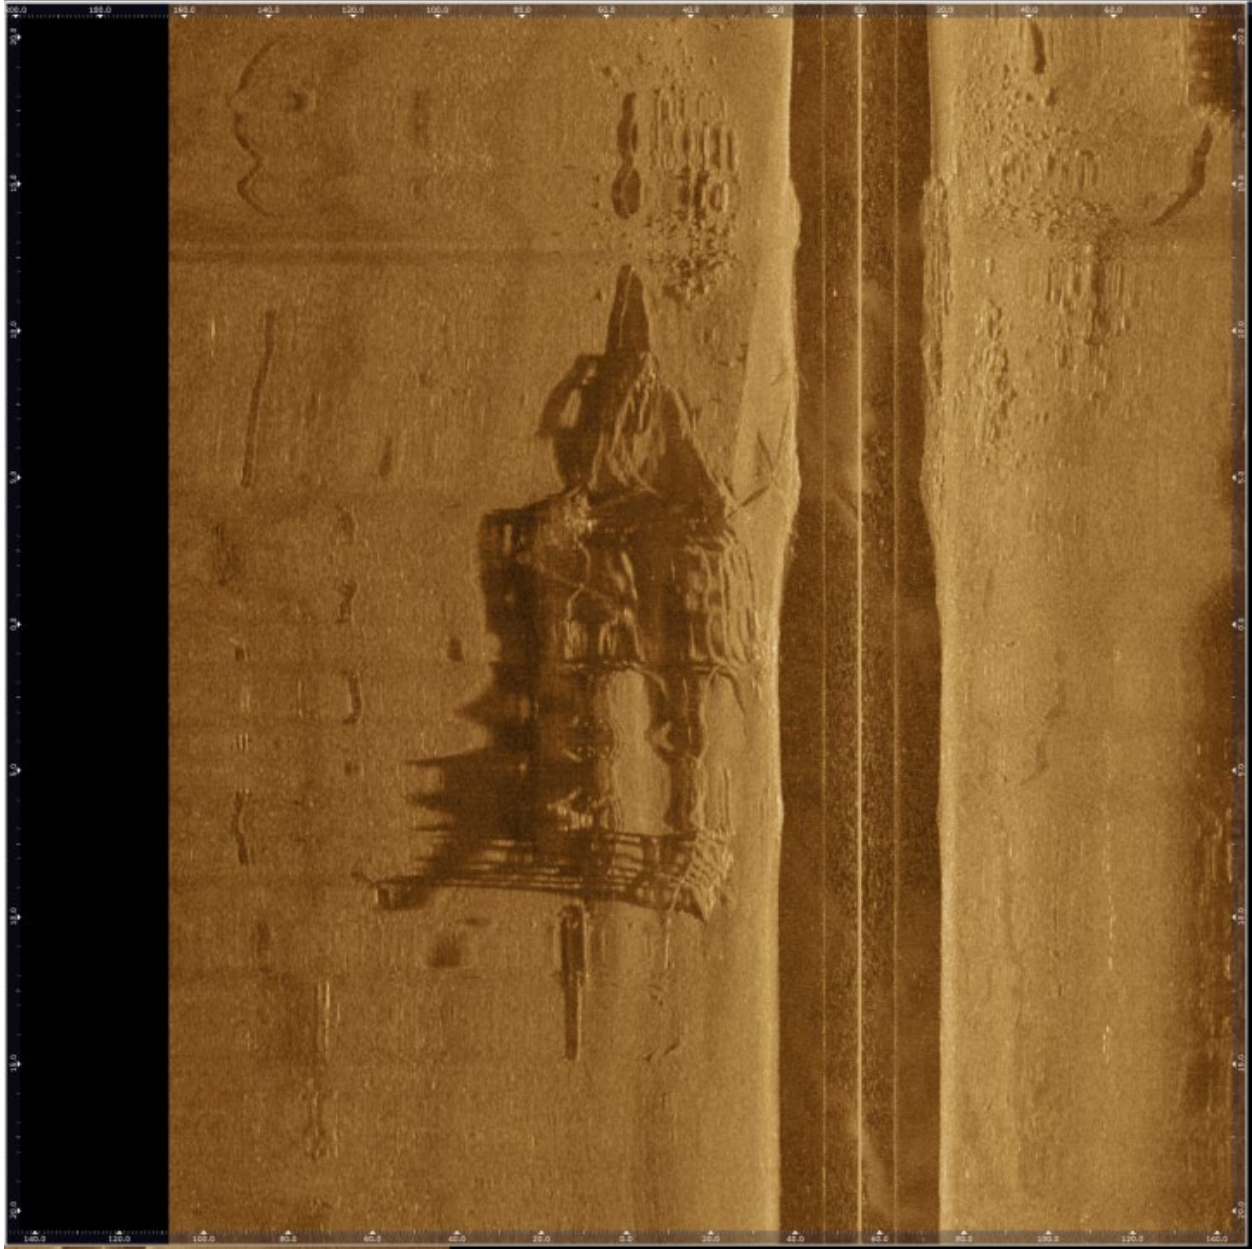
Figure 6. Overall morphology detail.

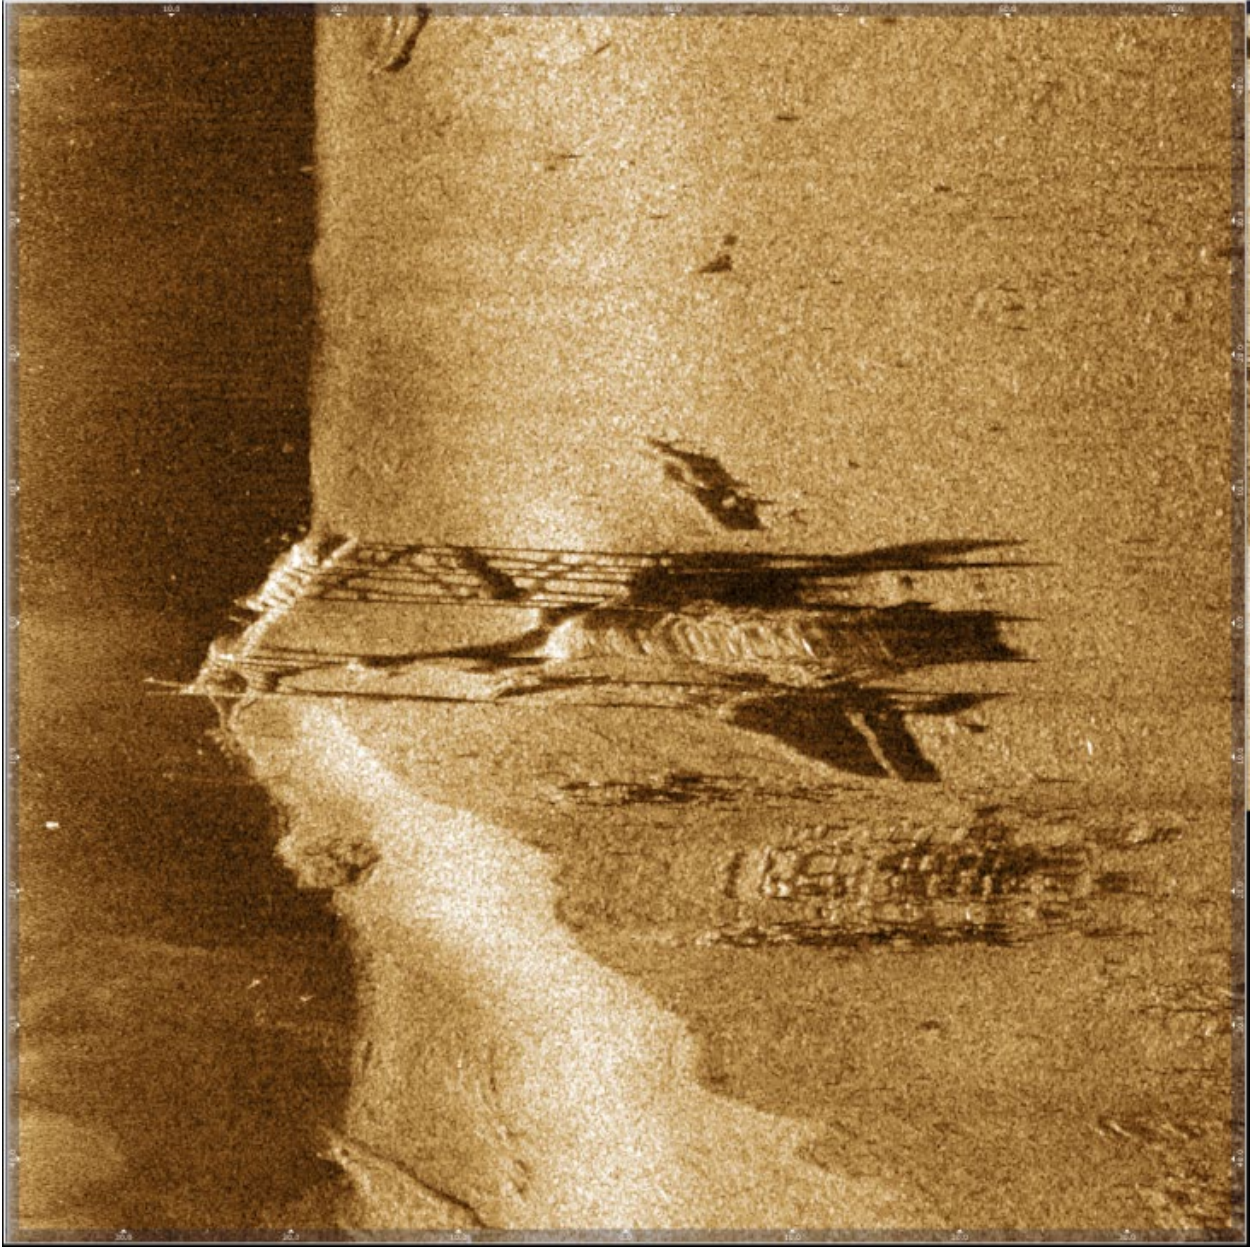
Figure 7. Bisecting view showing relief

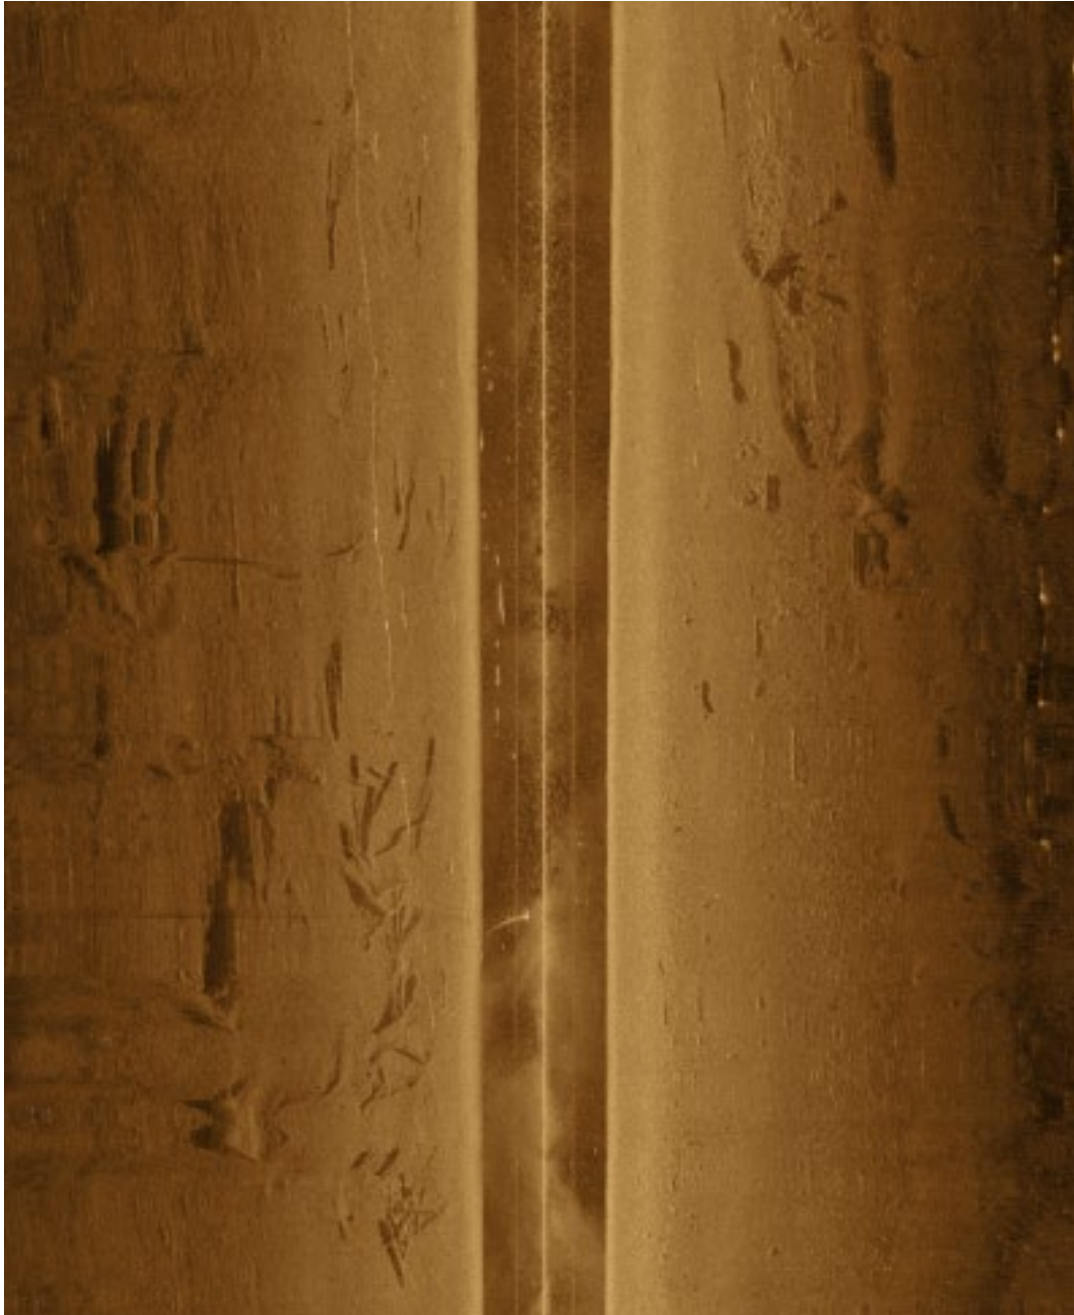
We imaged the section of the river between Hwy 45 and the Jackson Street Bridge off Park Plaza in three passes, collecting detailed imagery of the bottom off the area reported as an historic shipyard. This area is also reportedly where an anchor was recovered by magnet fishermen. This area is imaged in tracks S250412\_16 and S250412\_17. There are notable deposits of logs and possible manmade debris on the river bottom off this area but none

are larger than about 25 ft. We were able to safely conclude that no historic vessel remains of significant size remain in this area.

Figure 8. Debris scatter in the historic shipyard area

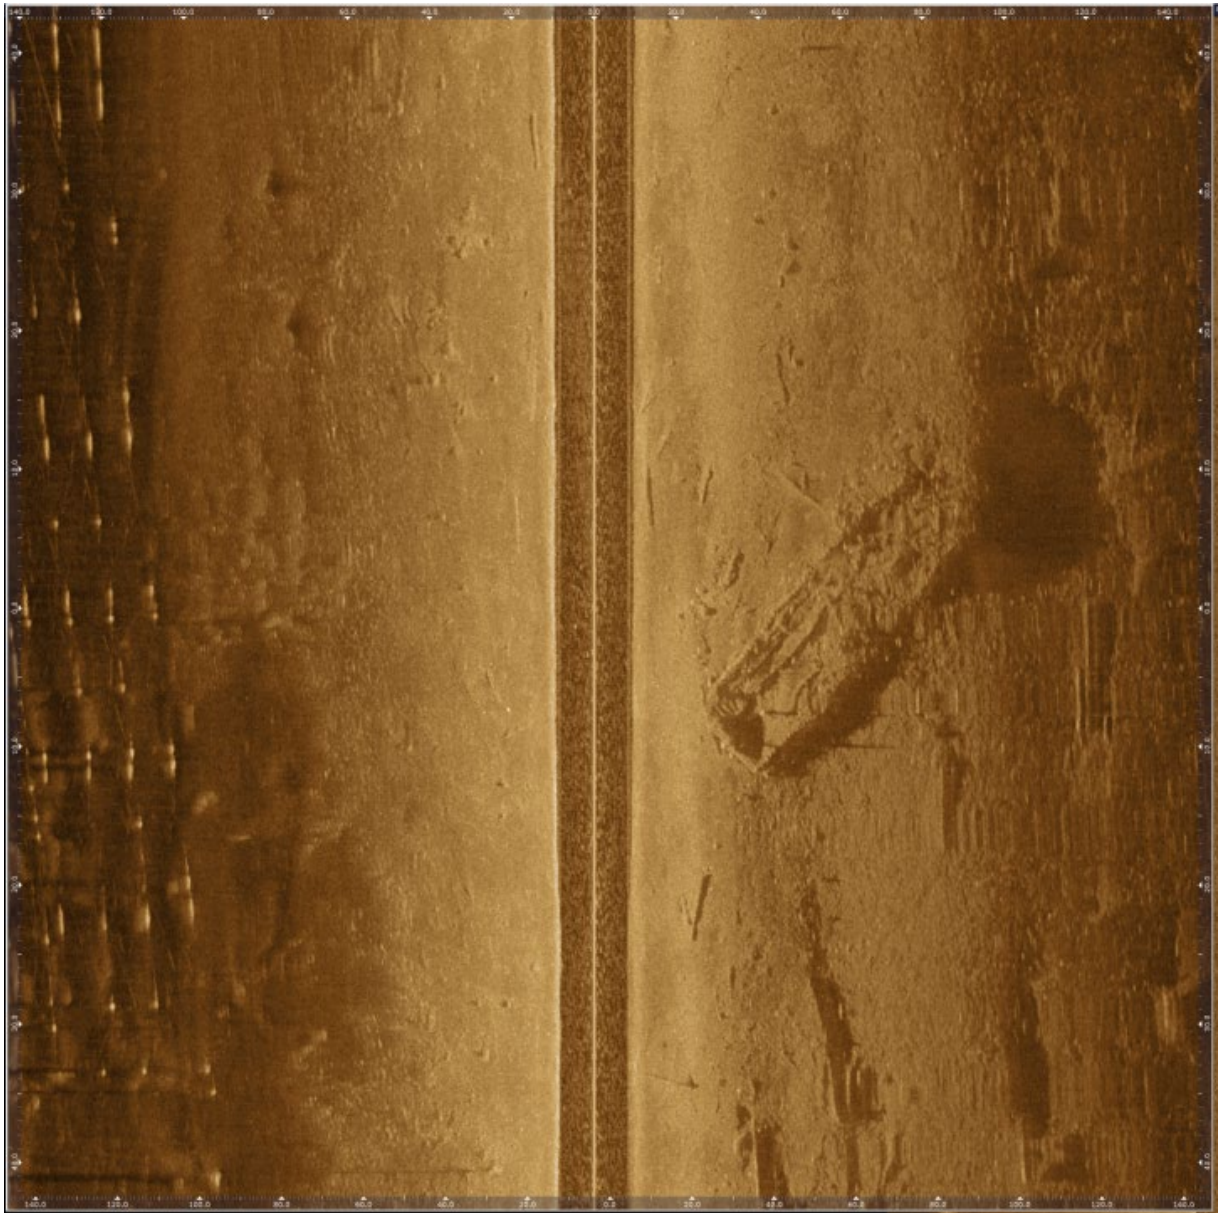
Figure 9. Possible L.W. Crane Wreckage

Acoustical measurement indicates that this hull is approximately 90 ft. long and 25 ft. wide. It appears to have a bow reminiscent of a scow schooner. With square features, but a clear center point. The wreck is partially buried and appears best on sonar when imaged from the north side. It is difficult to establish its size with great accuracy because the stern portion seems to be partially buried. The size and morphology is not entirely consistent with that of the Berlin City, which was reportedly 100 x 18 ft. However, the remains are fairly close in size to the paddle wheel steamer L.W. Crane of 100 x 20 ft., which burned in the immediate area in 1880. (See: <https://www.wisconsinshipwrecks.org/Vessel/Details/351>.) “The *L.W. Crane* burned to the water's edge at the St. Paul R.R. slip in Oshkosh during the summer of 1880.” A review of historical map data indicates that the St. Paul R.R. slip was almost immediately across the river from the location of this wreck, making the L.W. Crane a good candidate. Indeed, the large crushed rock caissons from the old St. Paul R.R. Bridge can be seen just over 100 yards NW of this wreck.

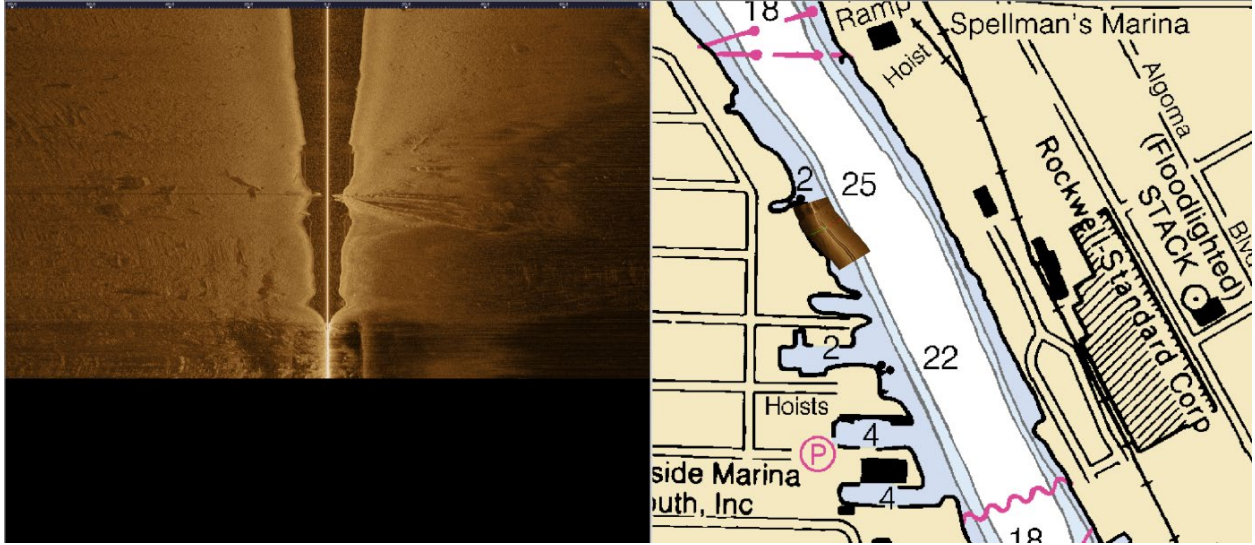
We were able to locate and image the remains investigated by Kevin Cullen and Brian Abbott in 2016. These remains are in very shallow water on the West side of the Fox River just outside the present-day Fox Harbor Marina. What appears to be the stern of the vessel points away from the shore with the length of the visible remains being about 50 ft. This vessel appears to have been pulled up on shore and gradually reduced by ice. The detail we obtained was not as good as that obtained in the 2016 survey as we were limited by shallow depth. The radial sector scan sonar used by Cullen and Abbott was ideal for surveying this site. Our findings were generally consistent with those of the 2016 survey, although the measured extent of the wreckage we could see was around 50 ft. as opposed to the 68 ft. measured by Cullen and Abbott. It is noteworthy that the mast feature identified in the 2016 survey is no longer present. Based on the large number of logs we noted in the area, it is probable that this feature was a transient log that has since moved down the river. Due to its shallow depth, this wreck is rather fragmentary and difficult to assess. It is clearly a vessel but its location is inconsistent with the historical location of the Berlin City, which reportedly drifted down stream.

Figure 10. Relative location of Kevin's Wreck.

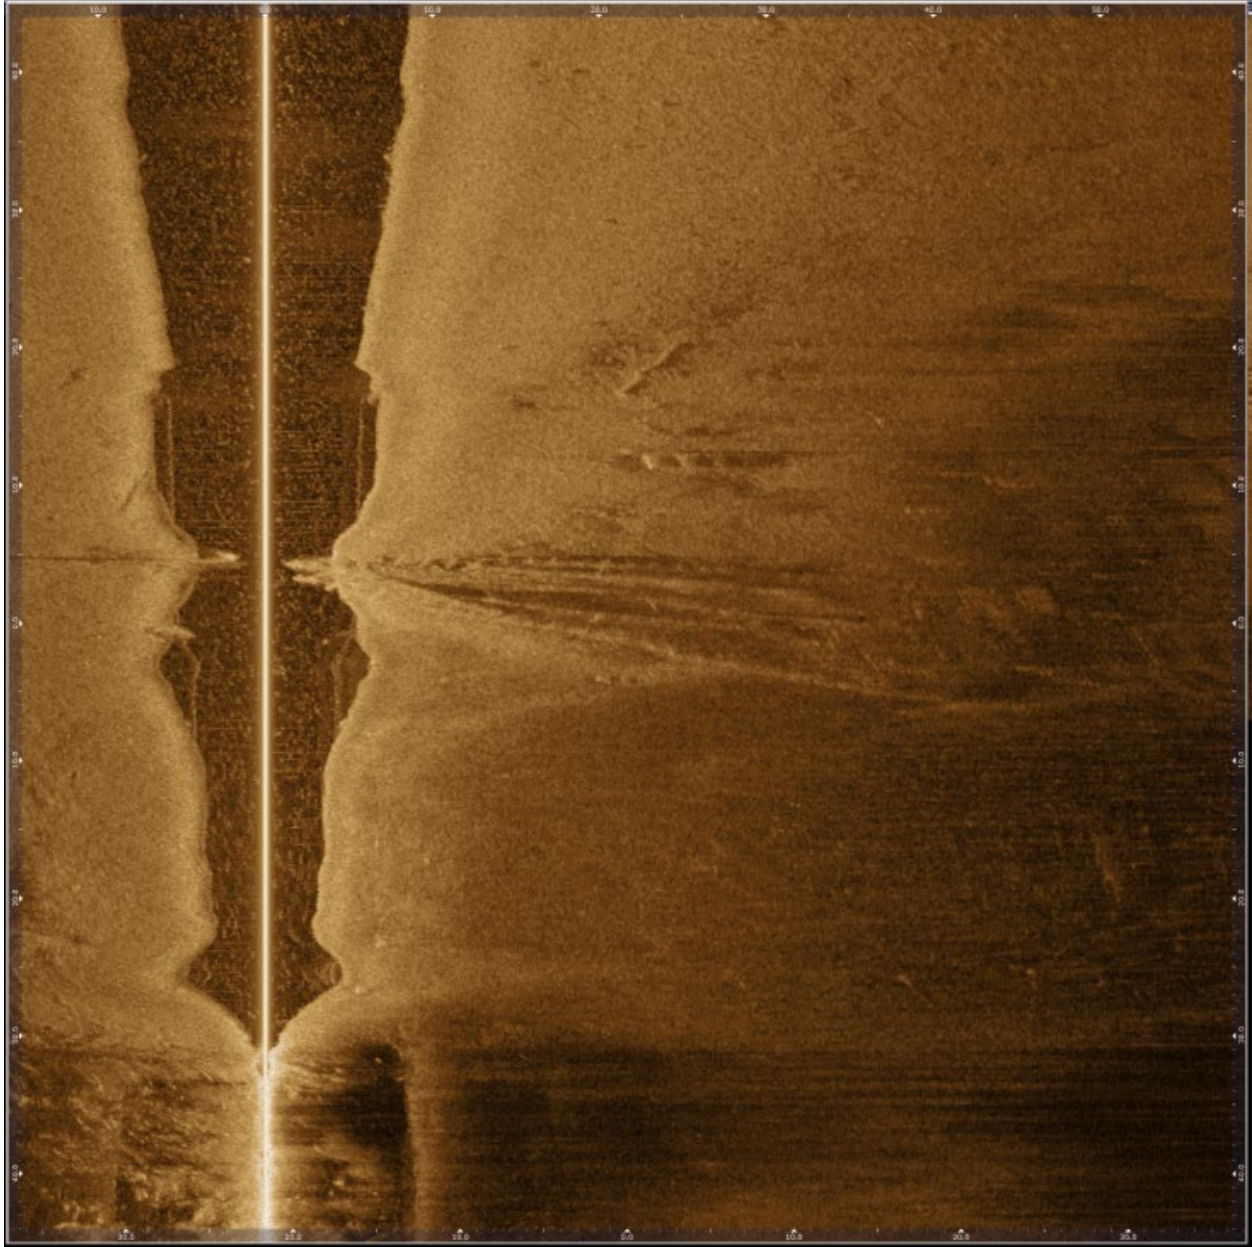
Figure 11. Detail of Kevin's Wreck
